EROSION TESTS ON NARROWS DAMSITE FOUNDATION
SAMPLE NO. 9B-1040 TAKEN FROM TEST PIT NO. 3
AT AN ELEVATION OF 4373.7 FEET--EMERGENCY
SPILLWAY--NARROWS DAM--MISSOURI RIVER BASIN

Hydraulic Laboratory Report No. Hyd.-265

DECEMBER 2, 1949

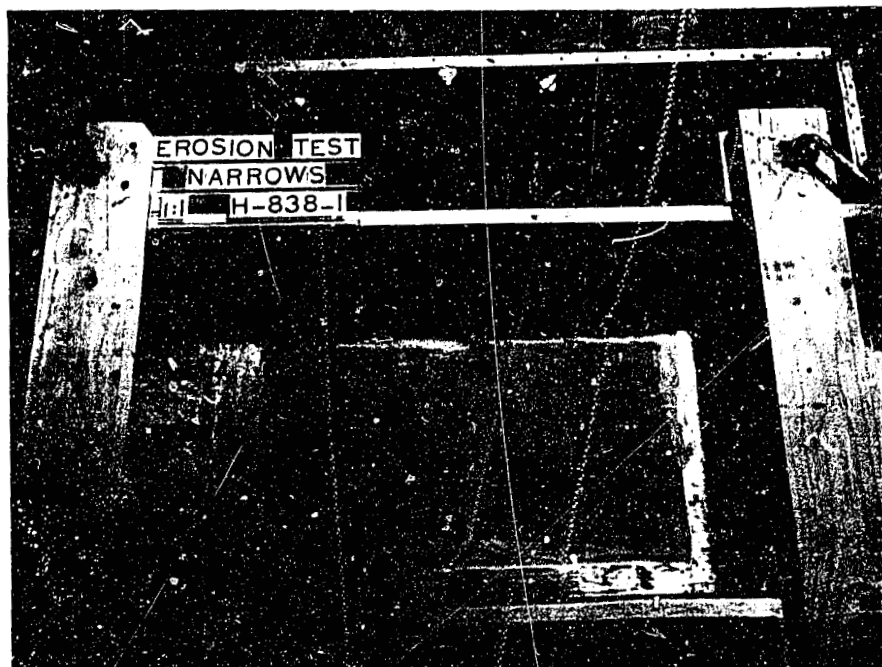
Figure 2

Two test specimens approximately 8 inches thick, 10 inches wide, and 20 inches long were prepared from Sample No. 9B-1040 by the Earth Materials Laboratory for the erosion tests conducted by the Hydraulic Laboratory. One of these specimens was placed in the test box with the side which was uppermost in the field on top in the box and level with the floor of the chute. The space between the sample and the sides of the box were filled with sand to within one-half inch of the chute floor. Modeling clay was then placed in the remaining space to form, as nearly as possible, a smooth continuous transition from the floor to the top surface of the specimen (Figure 2A).

A. Appearance of Test Specimen No. 1 before start of erosion tests.

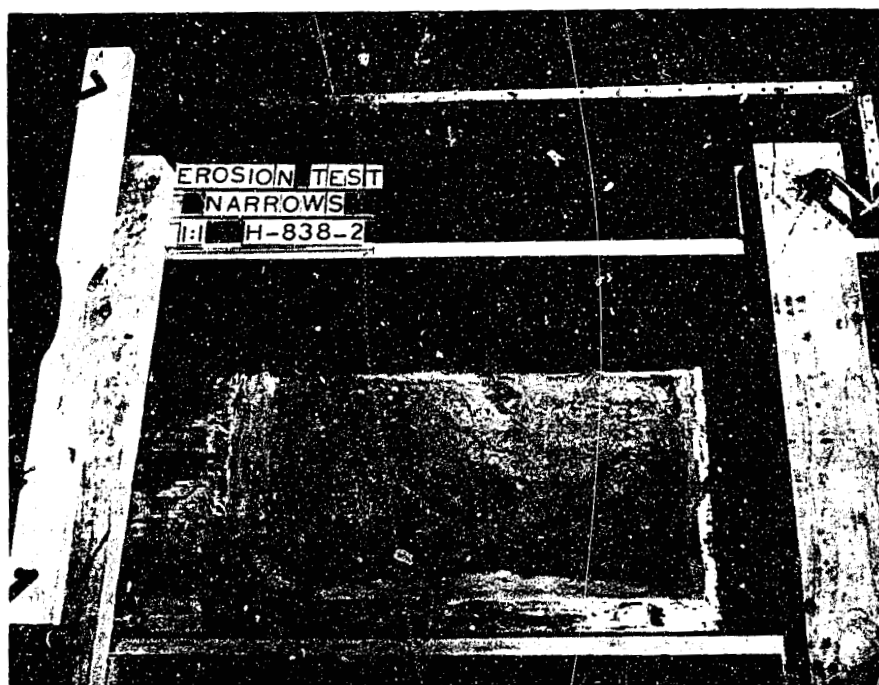
The first erosion test was conducted using a water velocity of 2 feet per second. Considerable clay was immediately dislodged from the specimen in flakes and small pieces which broke away along natural seams and fractures. This action continued at a decreasing rate for about 4 minutes. After this time, only an occasional flake was carried away. There was no noticeable tendency for the clay to dissolve and wash away. After 1 hour and 40 minutes' operation, the flow was stopped and the specimen examined. The regions where the pieces were dislodged were well defined, occurring along seams and fractures, and were eroded a maximum of five-eighths inch below the other portions of the specimen (Figure 2B). A close examination of the "uneroded" material revealed that extremely thin, minute flakes approximately one-thirty-second inch in diameter had been removed from the specimen. However, the clay dislodged by this action was negligible.

B. Erosion after 1 hour and 40 minutes' exposure at 2 fps velocity.

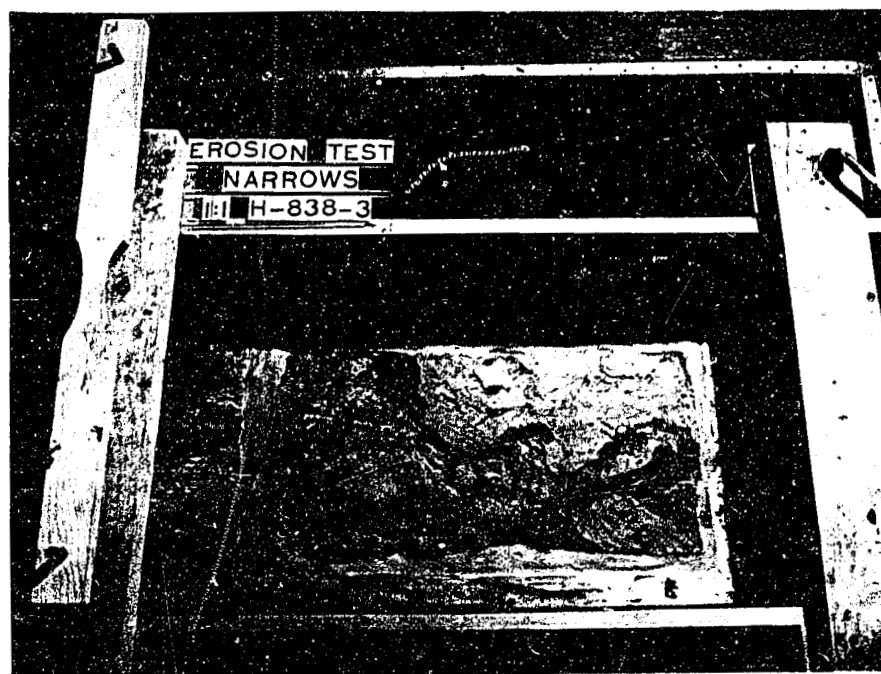
Successive tests were made using velocities of 4, 6, and 8 feet per second for durations of 1 hour, 1/2 hour, and 1/2 hour, respectively. All tests were made on the same specimen and the cumulative erosion at the completion of each run is shown in Figures 3A, 3B, and 4, respectively. The erosion action at these higher velocities was similar to that for the 2-foot per second velocity whereby nearly all the clay removed was swept away in pieces during the first 4 minutes of operation. The maximum depth of erosion was 1-3/8 inches while the average depth for the specimen was one-half inch.

A. Erosion after 1 hour and 40 minutes' exposure at 2 fps, and 1 hour at 4 fps velocity.

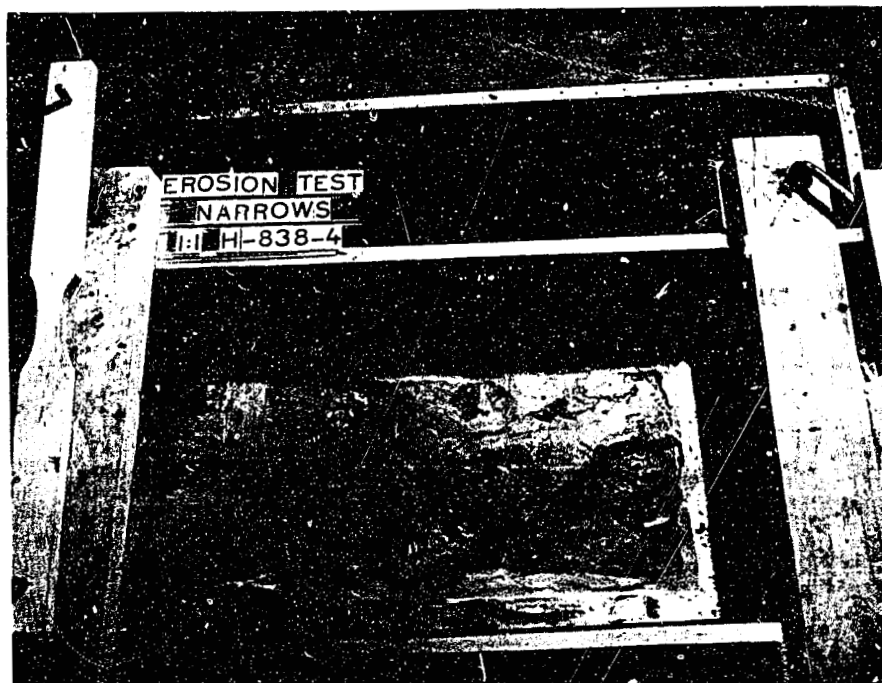
B. Erosion after 1 hour and 40 minutes' exposure at 2 fps, 1 hour at 4 fps, and 1/2 hour at 6 fps velocity.

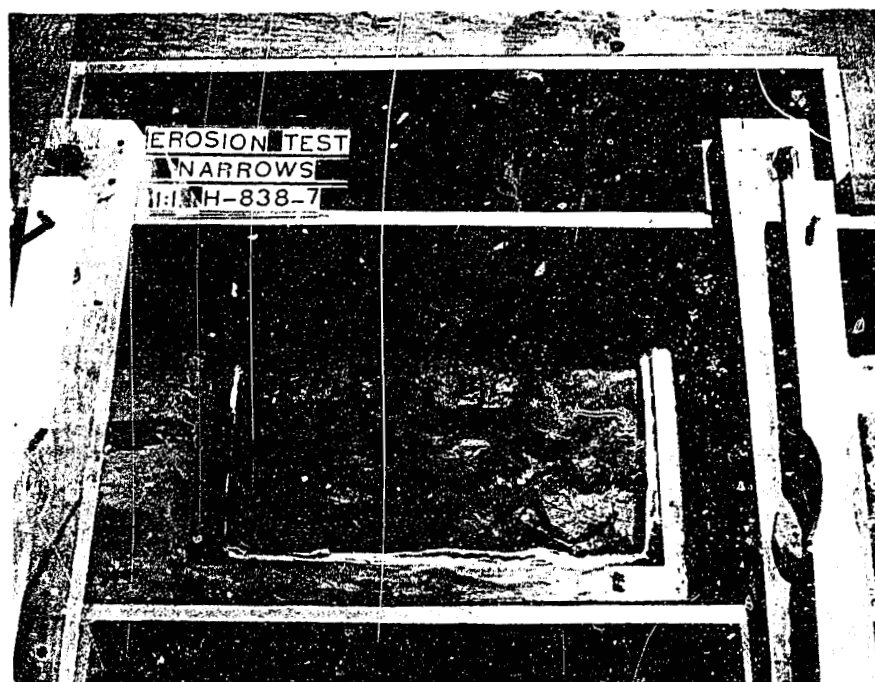
After completing the 8-foot per second test, the surface of the specimen was raised 2 inches above the chute floor and then cut and trimmed down to the floor level, thereby obtaining a smooth surface (Figure 5A). Water was passed over this new surface at velocities ranging from 12 to 16 feet per second for a total duration of 3 minutes. Considerable clay was dislodged from the specimen, most of it being in irregular pieces 2 to 3 cubic inches in volume. The maximum depth of erosion was 2-3/4 inches while the average depth was 1-1/4 inches. One portion of the specimen, however, remained unaffected by the flow (Figure 5B).

B. Erosion after 3 minutes' exposure at velocities ranging from 12 to 16 fps.

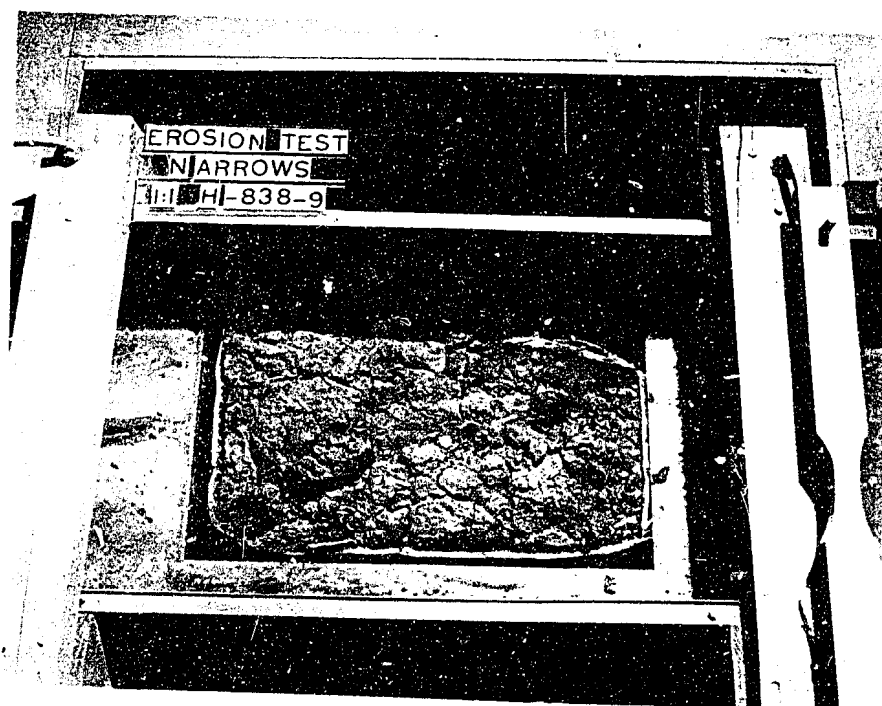
To determine the effect water will have when flowing over weathered areas of this clay, a test was made using the second specimen cut from the original sample. This block was placed in the test box and exposed to alternate 1/2-hour wetting and 3-day drying periods for a total of 4 weeks. At the end of this time, the surface of the specimen was weathered to a depth of about 1 inch and when dry, resembled a dried, cracked mud flat (Figure 6A). Water was passed over this specimen at a velocity of 1.5 feet per second. Immediately the weathered clay began to wash off in quantities great enough to color the water an opaque brown. Only 2 minutes were required to remove the weathered material and at the end of this time the water was shut off. Numerous small loose pieces which would be swept away by higher velocity flows were found scattered over the surface of the specimen. Several mica deposits were found protruding above the specimen surface as they had been unaffected by either the weathering process or the flowing water (Figure 6B). Further erosion on the specimen would have occurred in the same way as in the tests on the first specimen, and therefore the testing was discontinued.

B. Erosion after 2 minutes' exposure at 1.5 fps velocity.
